**Redbrick Structural
Engineers Ltd**

Our Ref: 7788/KW

13th June 2024

Structural survey
Bishop's Drive Bridge, Southwell, Newark, Notts

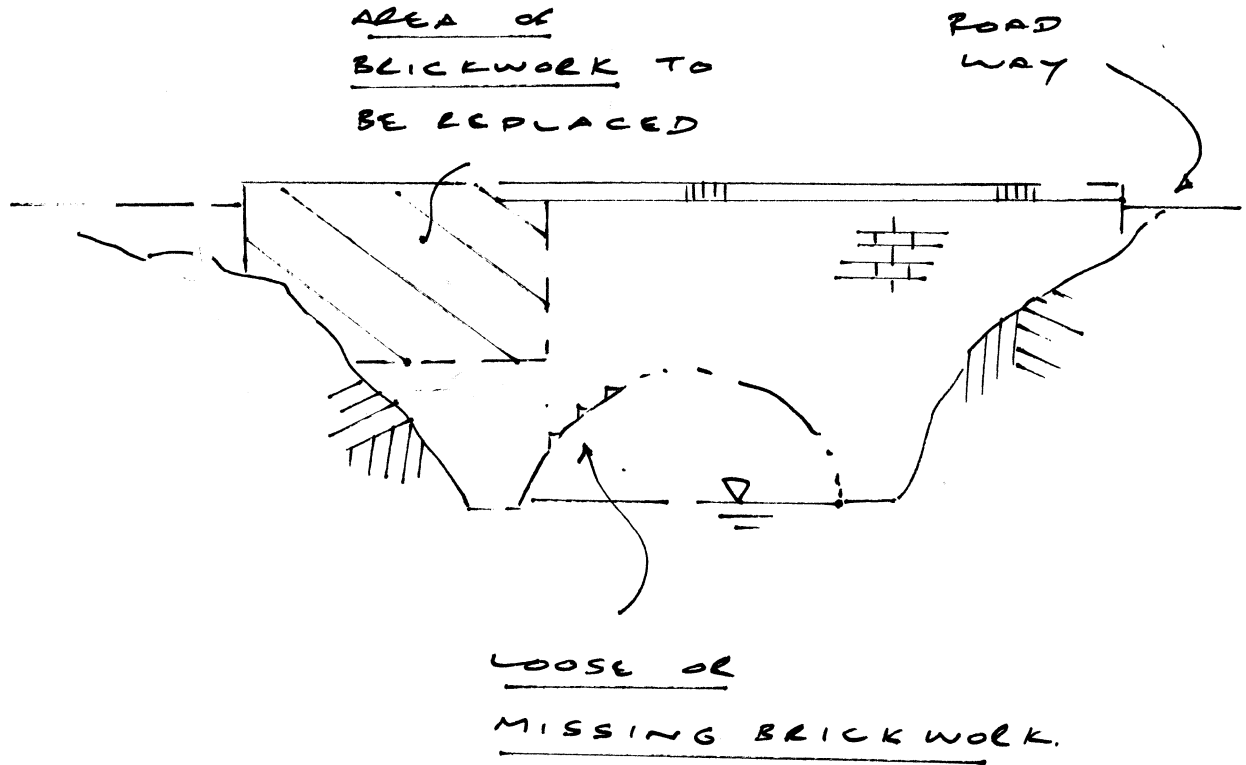
Job number/Sheet number 7788 / 01.

Project <u>RIGHT HAND SIDE ABUTMENT.</u>			
Made by

- *Re-build front of right-hand abutment* – Prior to any re-building work secure ply to underside of arch and prop with scaffold tubes. Props to be supported off scaffold boards and braced. Once propped, carefully take down, 225mm wide, out of alignment brickwork to front of arch and re-build to correct vertical alignment.

Use 'Ibstock old county' or similar bricks (a water-resistant brick). Anchor back new brickwork to structure with stainless steel masonry ties where possible. Between every other brick course reinforce with stainless steel ladder masonry reinforcement – 'Bricktor' or similar. Use 'Spec Mix' mortar w/ integral water repellent or again similar;

See attached sketch sheet no. 7788/01 for the proposed elevation.
